Manhole Inspection Summary

Manhole # S23II_035MH

Location Address: **544 BAKER ST**

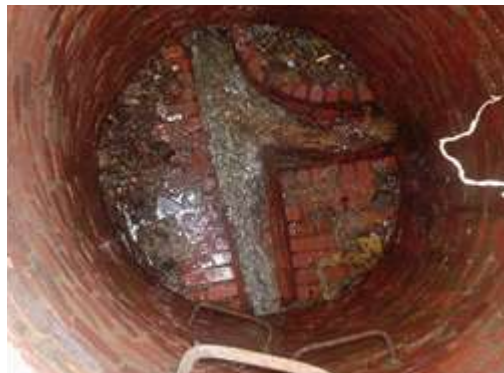
Top View

Corroded steps. Evidence of surcharge - Bench debris. Channel debris.

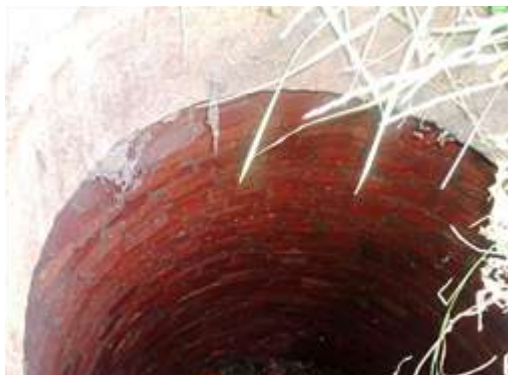
Defect

Frame leaks. Corbel and Barrel infiltration.

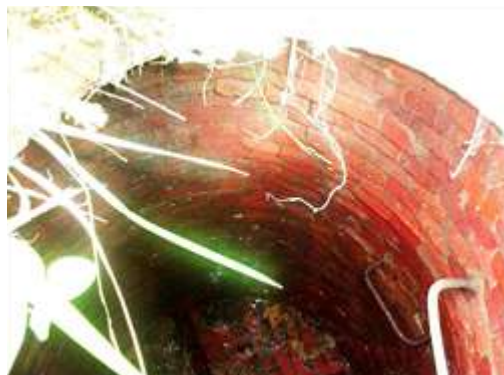
Defect

Frame leaks. Corbel and Barrel infiltration - other side.

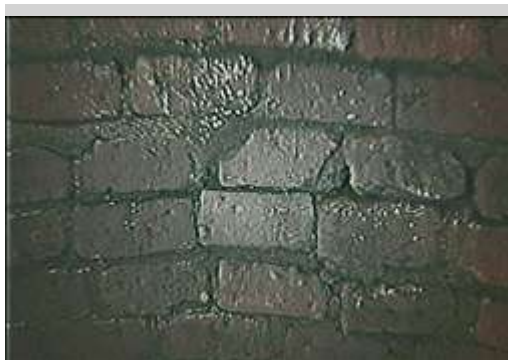
Defect

Barrel deterioration and infiltration (Active).

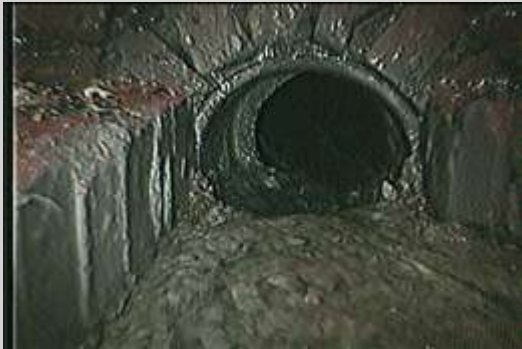
8 in. Circular Gravity Sewer Pipe Out @ 12 O'Clock

Infiltration: **Evidence** Pipe Seal Cond: **Cracked**

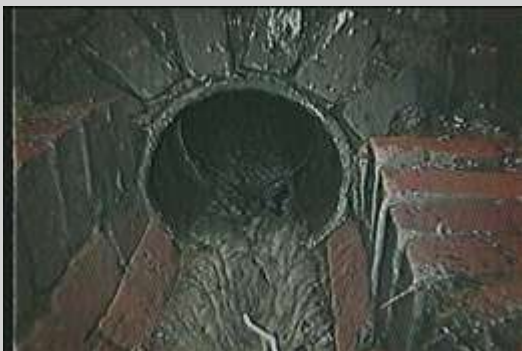
8 in. Circular Gravity Sewer Pipe In @ 3 O'Clock

Barrel deterioration and infiltration. Channel and Bench deterioration.
